**Re: Onondaga Lake Project, Task 5: 104(e) Review
Site Summary Report, Bristol-Myers Squibb (Site IDs 268, 356-365)**

SITE IDs 268, 356 - 365 : BRISTOL - MYERS SQUIBB COMPANY

SITE SUMMARY REPORT

**Onondaga Lake Project
Task 5: 104(e) Review**

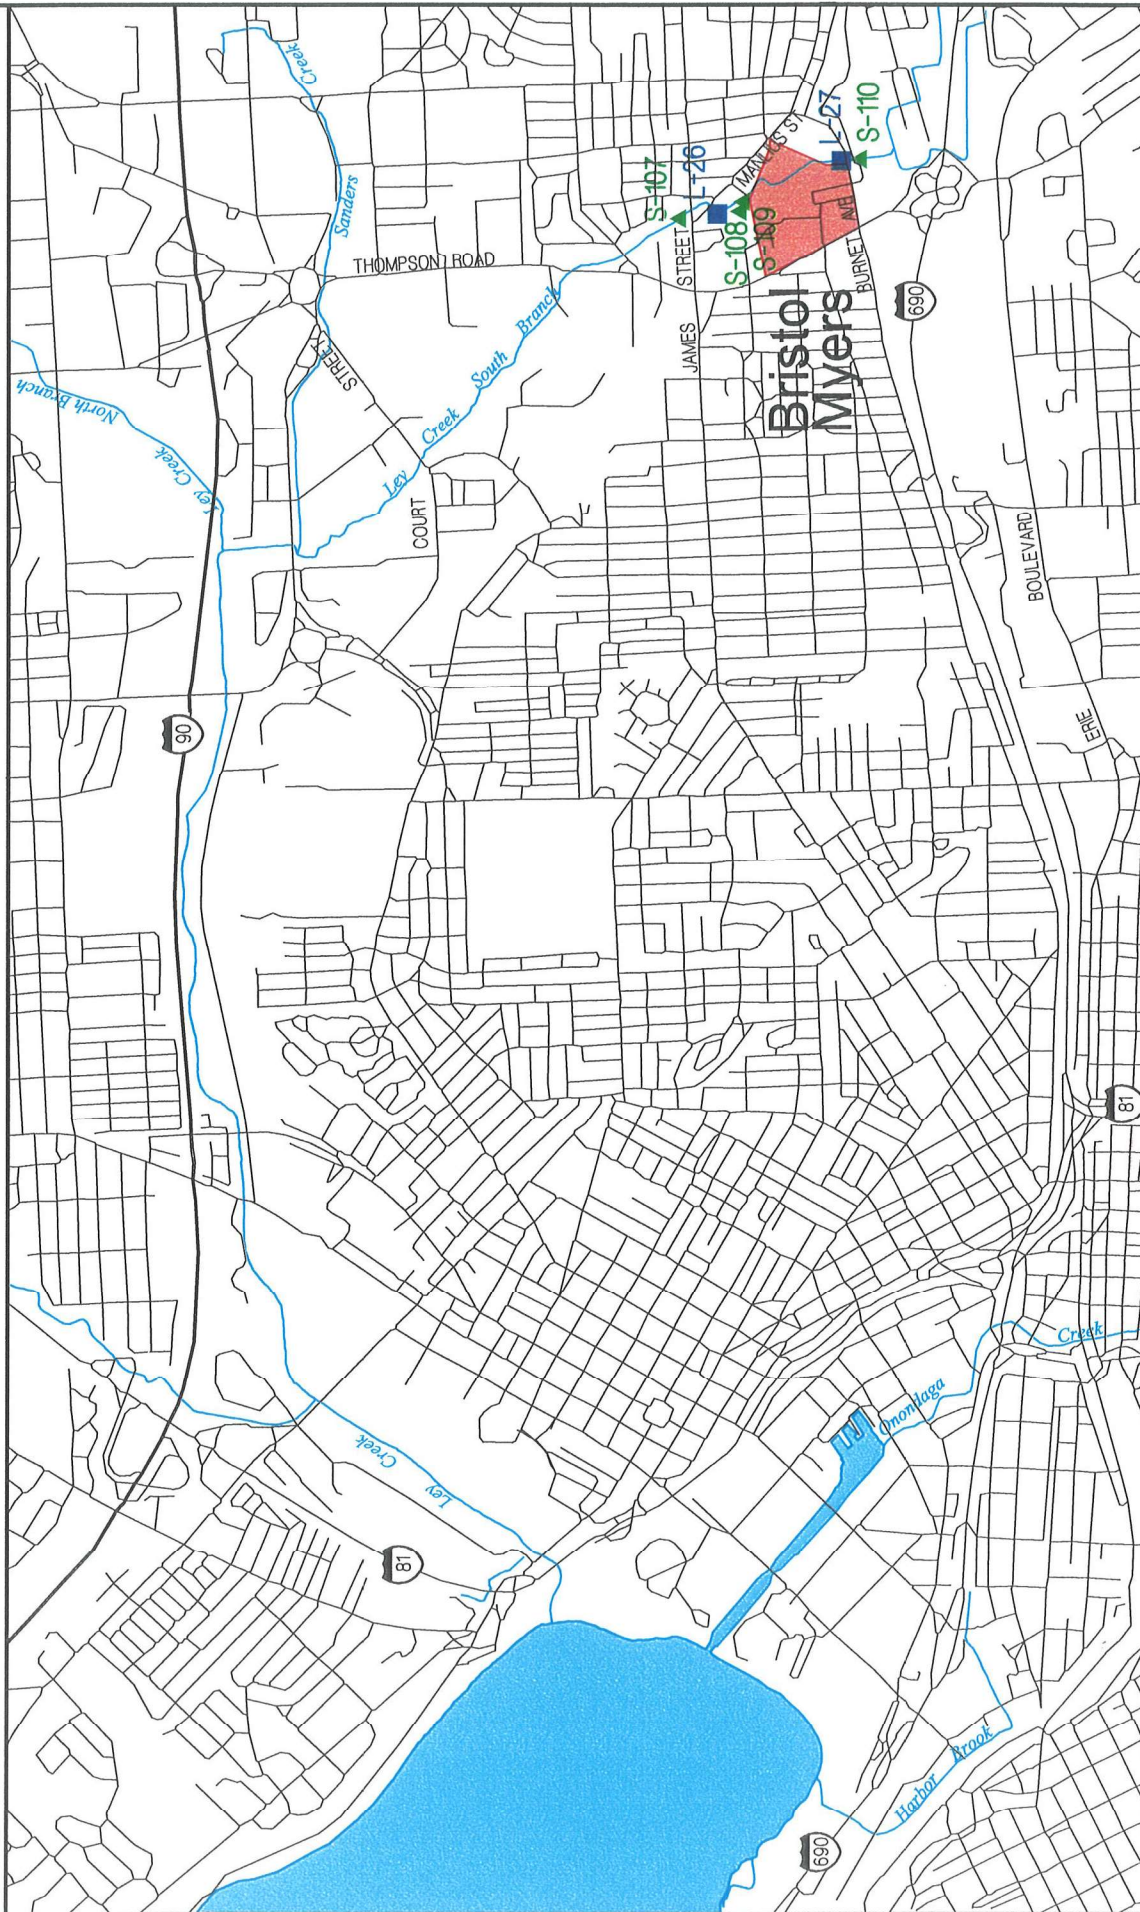
NYSDEC Sediment Sample Locations Near Bristol Myers Thompson Road Facility

Analyses of metals, VOCs, SVOCs and PCBs in sediment were examined in six samples collected in the vicinity of the Thompson Road site including five samples in the South Branch of Ley Creek and one sample (S-108) in Headson's Brook, located along the northern perimeter of the Bristol property. Of the five samples collected in the South Branch of Ley Creek, one sample (S-110) was collected upstream of the site and upstream of Burnet Avenue, one sample (L-27) was collected near the upstream limit of the site but downstream of Burnet Avenue, one sample (S-109) was collected near the downstream limit of the site, and two samples (L-26 and S-107) were collected farther downstream (see Figure 6). Sediment samples L-26 and L-27 were collected by NYSDEC in 1996. Samples S-107, S-108, S-109, and S-110 were collected by NYSDEC in 1997. The descriptions of the sample locations based on NYSDEC's field notes are included in the tables in Appendix C.
